# Restori

# ing Arborfield

**Part 1:**How we  
got in a mess

#### **The Study Site**

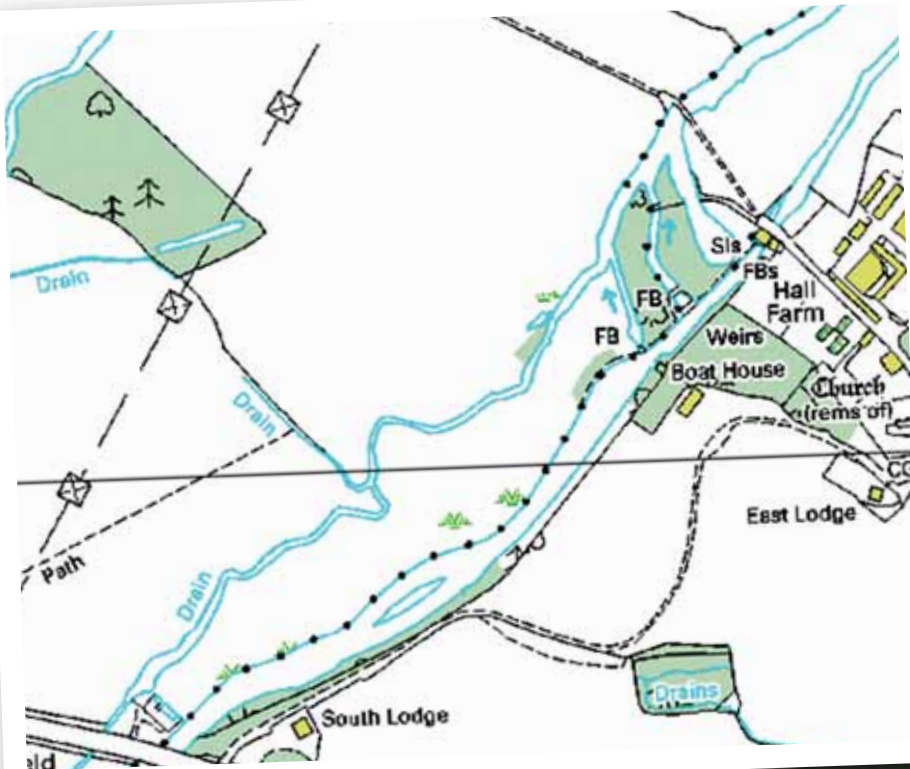
*A suspiciously straight river Loddon at Arborfield.*

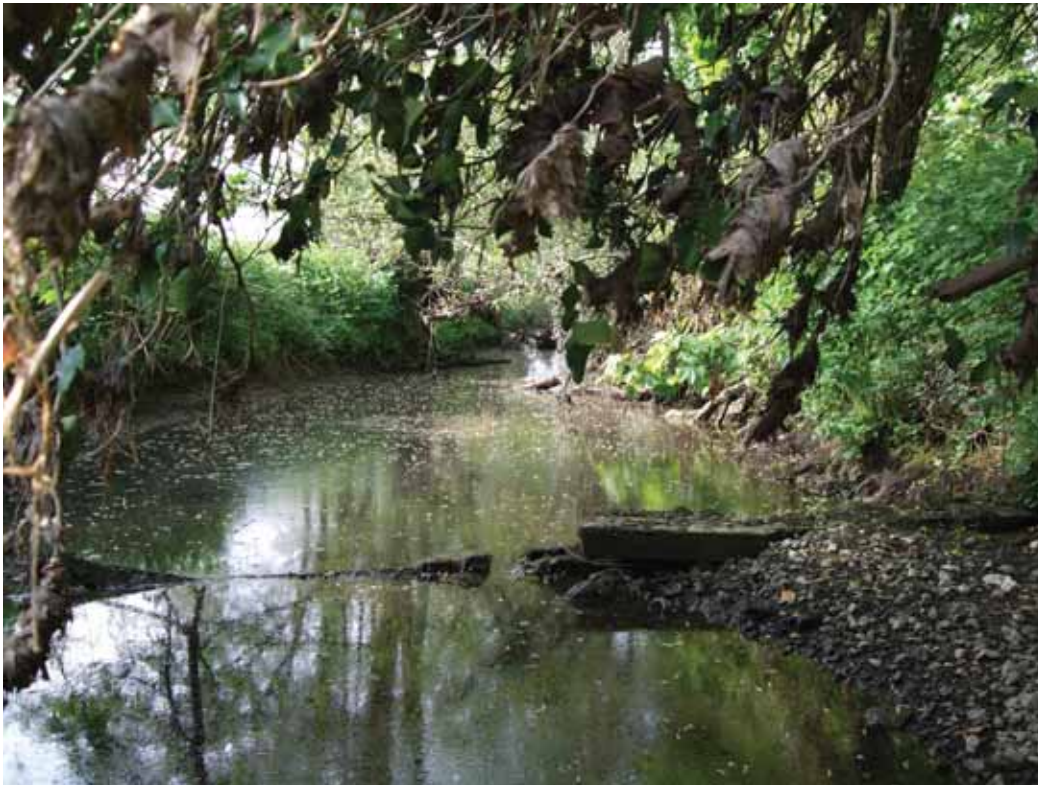
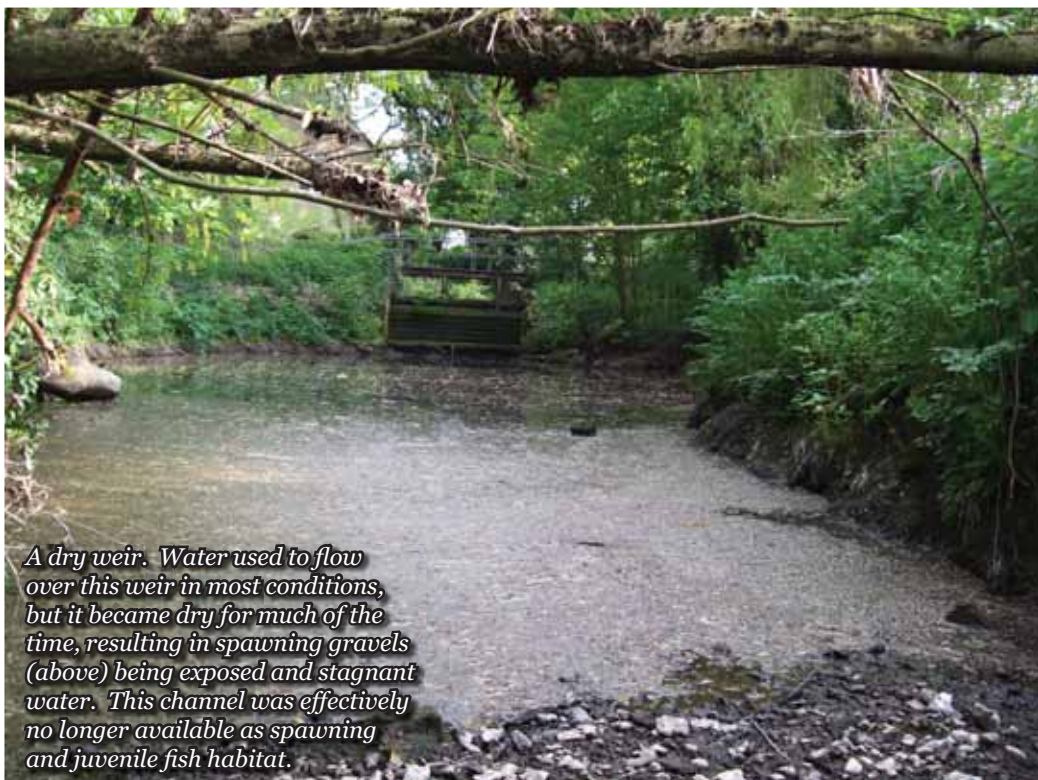
*A dry weir. Water used to flow over this weir in most conditions, but it became dry for much of the time, resulting in spawning gravels (above) being exposed and stagnant water. This channel was effectively no longer available as spawning and juvenile fish habitat.*

In some places, there was no water but in the main pool below the weir, there was too much flow. With less water going through the other channels, most of it went through the main pool making flows much more aggressive than previously. This flow concentration dried up other spawning channels and EA surveys had showed that the tails of the pools had been important

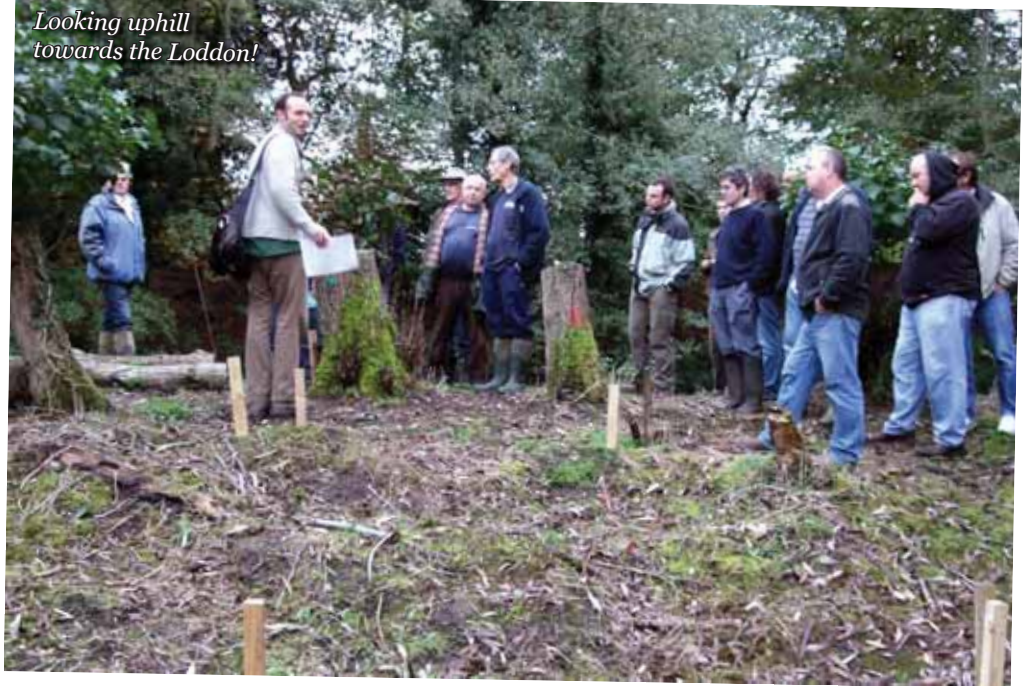
*Looking uphill towards the Loddon!*

However, if you walk the left hand bank, something strikes you as very odd; the river is above you! Rivers do not do this naturally and this “perched” river is the result of some radical
